# Blackmaxx, Tracer, Rampage Retrofit Guide

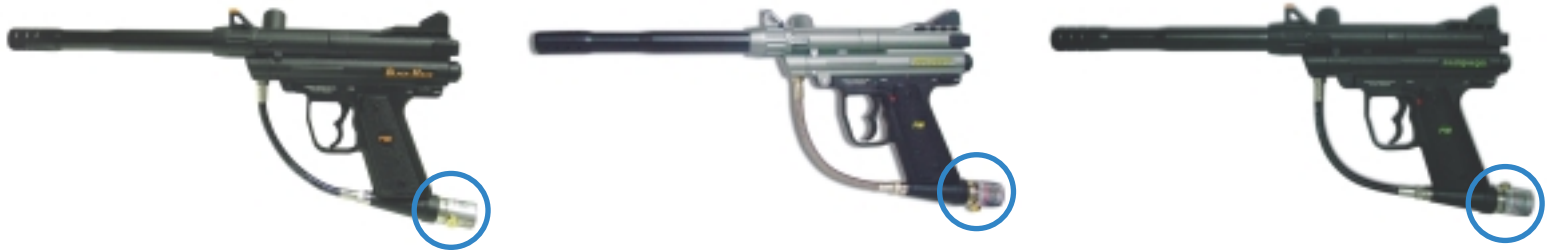
## FIGURE 1

All of the markers in figure #1 have the external retrofit device installed as shown circled in blue below. These markers are ready to use!

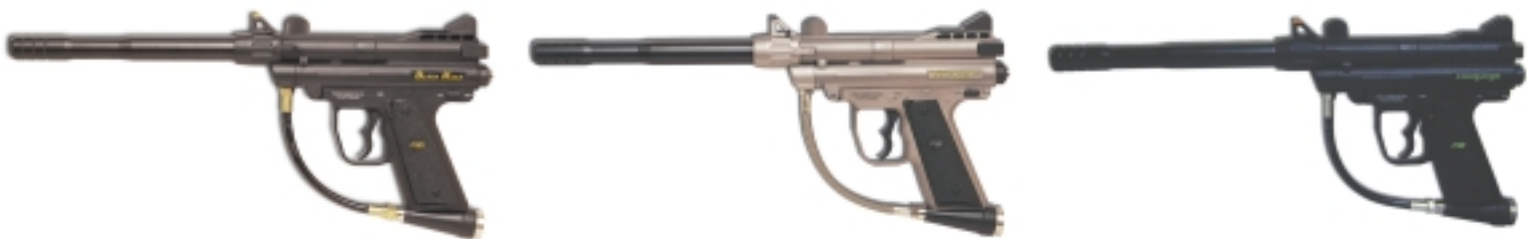
## FIGURE 2

All of the markers in figure #2 do not have the external retrofit device installed. However you must check to see if they have the new factory installed safety release device as shown in figure #3 & 4 before playing with this marker!

If your marker does not have the factory installed safety release device or the external retrofit device you must call or e-mail PMI to arrange for your free retrofit service. Call PMI toll free at 800-579-1633 or e-mail at [info@pminetwork.com](mailto:info@pminetwork.com) for further details regarding returning your marker for this free upgrade. Do not use the marker prior to calling PMI.

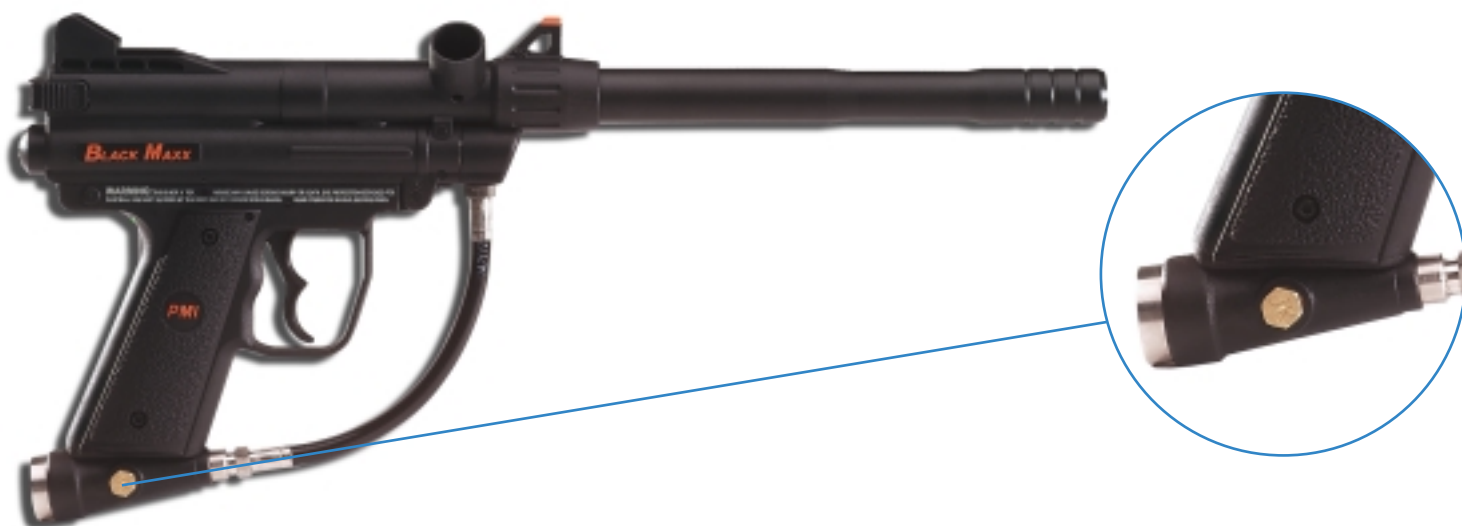
## FIGURE 3 & 4

The marker shown in figure #3 & 4 has the new factory installed safety release device. This marker is ready to use.
